ELECTRICAL INSTALLATION CONDITION REPORT

Address: Swansea University, Singleton Park, Caswell Block, SWANSEA

Purpose for which this report is required: 5 Yearly Condition Report

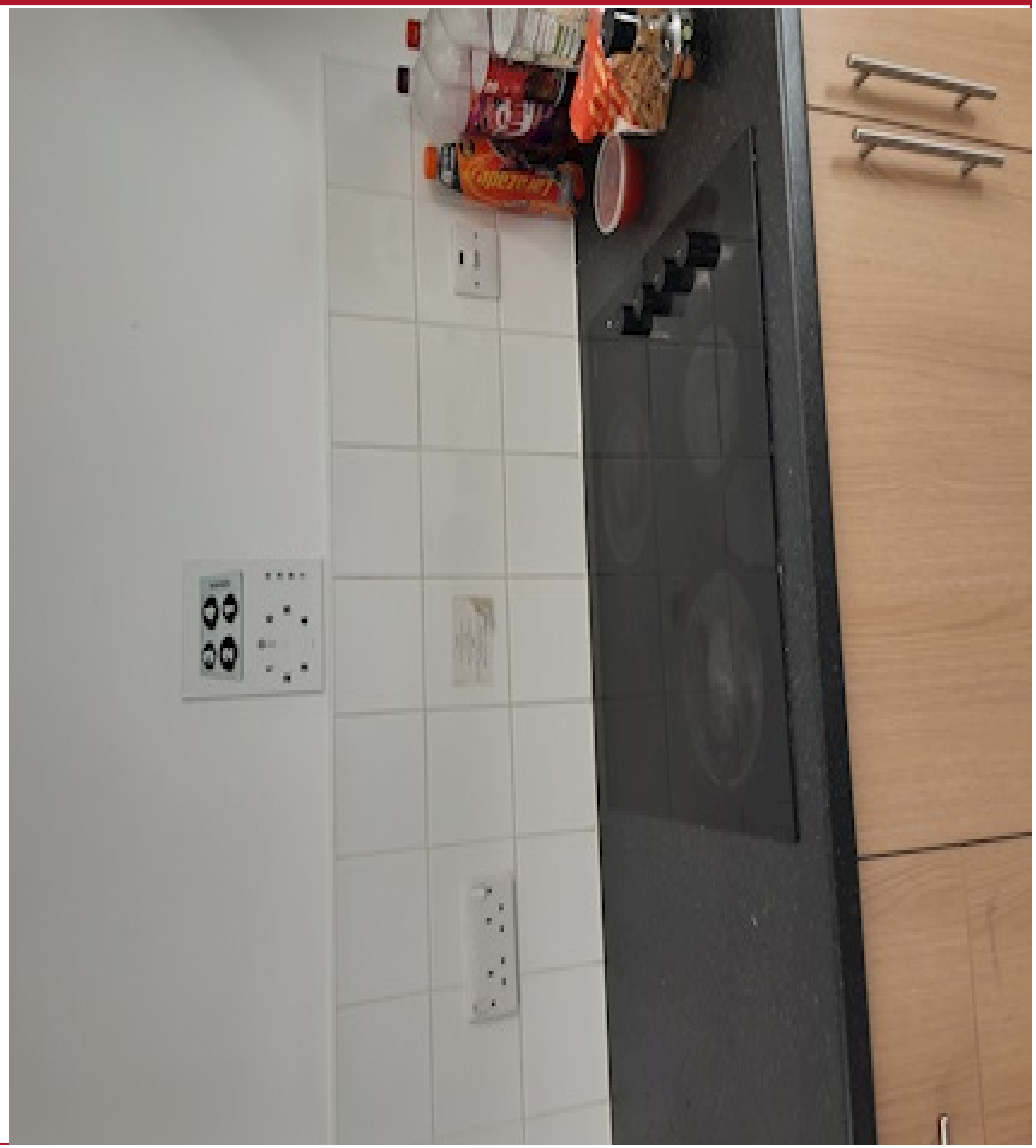
Switches within 100mm of hob no signs of thermal damage
